2022 ANNUAL DRINKING WATER REPORT

PANORAMA MOUNTAIN RESORT

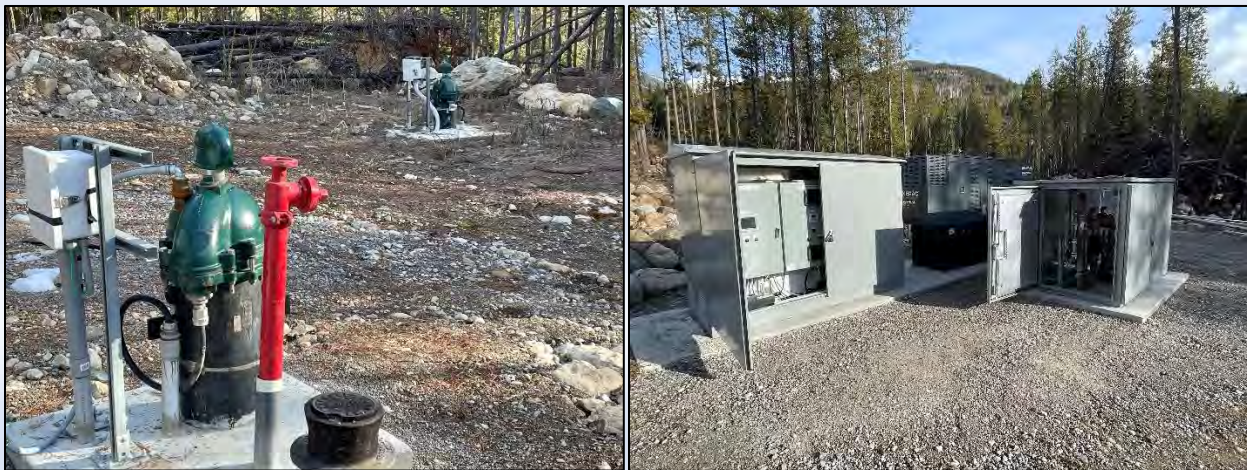
Panorama Well Site

Panorama's source water is from two, 10-inch diameter production wells in close proximity to the Toby Creek. In 2020, Corix transitioned from a surface water source to a clean groundwater source in order to alleviate the high levels of turbidity in the water during spring runoff. Well 15-02 has a total depth of 106.5 ft (32.5m) and well 20-03 has a total depth of 124.5 ft (37.9m). Both wells have been drilled into the same semi-confined sand and gravel aquifer system. This system is overlain by sediments containing silt and clay, while it is underlain by bedrock.

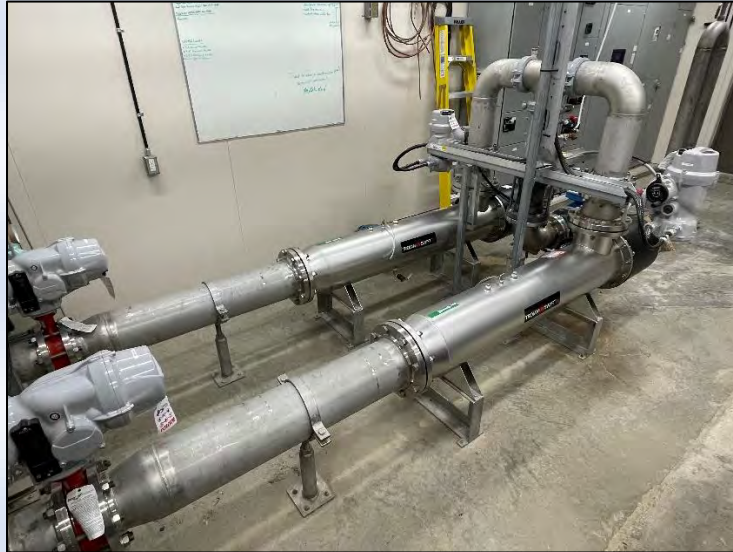
Panorama UV disinfection units

Panorama's source water is continuously pumped to a treatment station located at 2130 Trappers Way. There is continuous online turbidity monitoring for all water entering the treatment station. The first stage of disinfection is UV. Corix operates two Trojan UV Swift SC units. This UV disinfection process provides 99.99% inactivation of pathogens such as Cryptosporidium and Giardia. The next stage of disinfection is accomplished with chlorine. Corix administers a dosage using 12% Sodium Hypochlorite. The level of chlorine leaving the treatment station is continuously monitored, and is usually around 0.80 mg/L. The combination of using UV technology and chlorine disinfection creates a very efficient disinfection process by inactivating a large number of microorganisms.

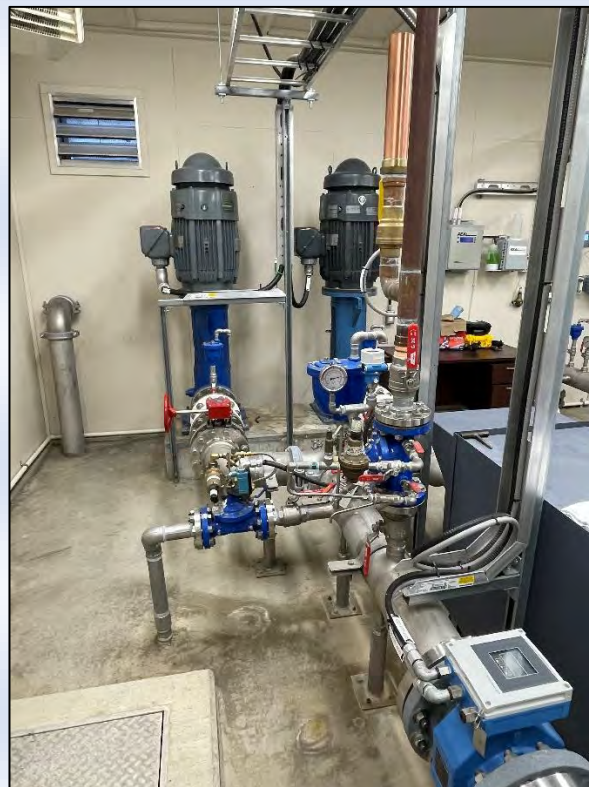
Treatment Station Booster Pumps

After disinfection is accomplished, the water is pumped into a clear well, which is located underneath the treatment station. This acts as a holding tank, as two booster pumps then move the water from the treatment station to the main resort reservoir. As water demands increase and decrease all tank levels remain constant as well pumps and booster pumps act in unison and modulate their flow rate accordingly.

In July 2022 it was discovered that Booster Pump #2 at the Treatment Station was exhibiting excessive vibrations while running. It was determined that the pump shaft had a slight deflection and pump impellers were badly worn. This pump and motor were then locked out until a repair took place. Later in the year, Mechanical Advantage was contracted to remove the pump and motor, complete the necessary repairs and replace the pump shaft. This entire assembly was reinstalled and the pump was put back into use at the end of December, 2022.

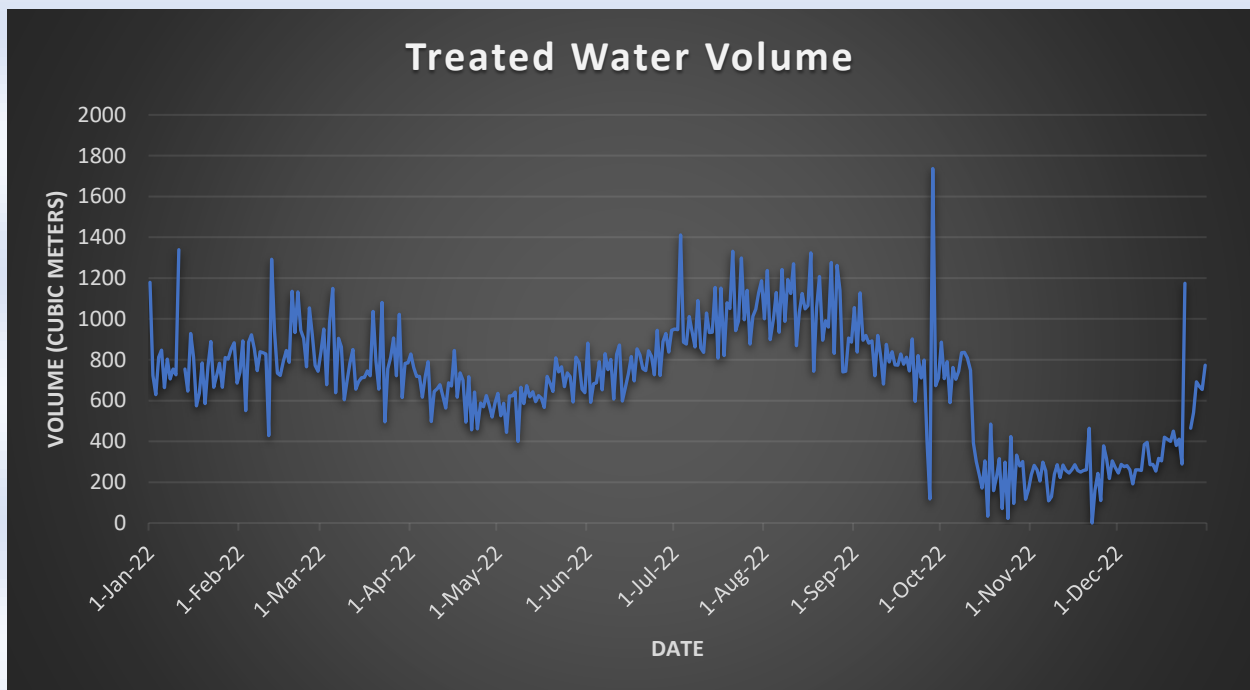
In 2022, Corix treated and distributed approximately 256,000 cubic meters of water (256,000,000L). Figure 1 below illustrates the amount of water that was treated daily over the course of the year. As can be seen, there are fluctuations throughout the year. This is due to the fact that Panorama is a seasonal resort destination. Higher flows can be expected through winter months (Dec – Apr) and summer months (Jul – Sept) due to higher occupancy rates. Summer irrigation also factors into a higher demand during summer months.

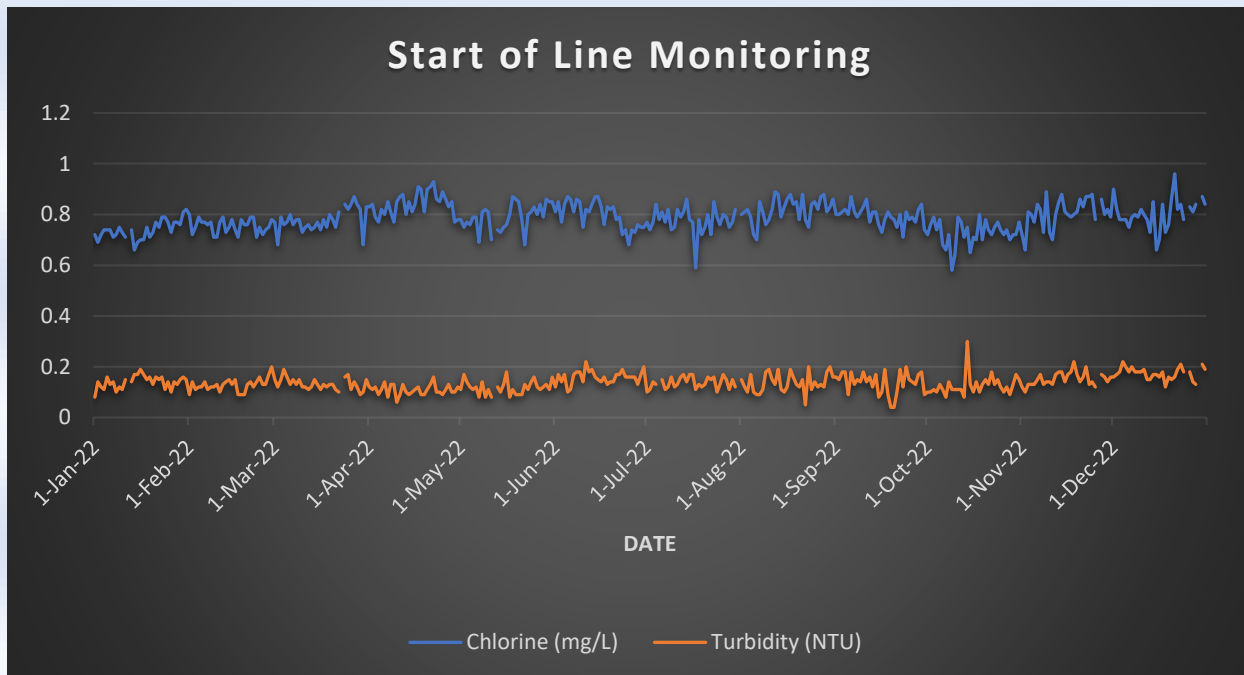
Everyday, Corix operators perform a set of daily rounds consisting of operational checks of the well site and booster station. Turbidity and residual chlorine checks are also completed everyday by an operator. Please refer to Figure 2 and Figure 3 for a snap shot of chlorine and turbidity levels found at the start and at the end of the distribution system through out 2022. By completing these checks at both the start and end of line, this ensures an adequate chlorine residual and turbidity level throughout the entire system.

Chlorine residual concentrations usually range from 0.20 to 2.0 mg/L in many Canadian drinking water distribution systems. Corix operators try to keep the residual around 0.80 mg/L through the system so as to ensure proper disinfection while minimizing the taste of chlorine for the customer.

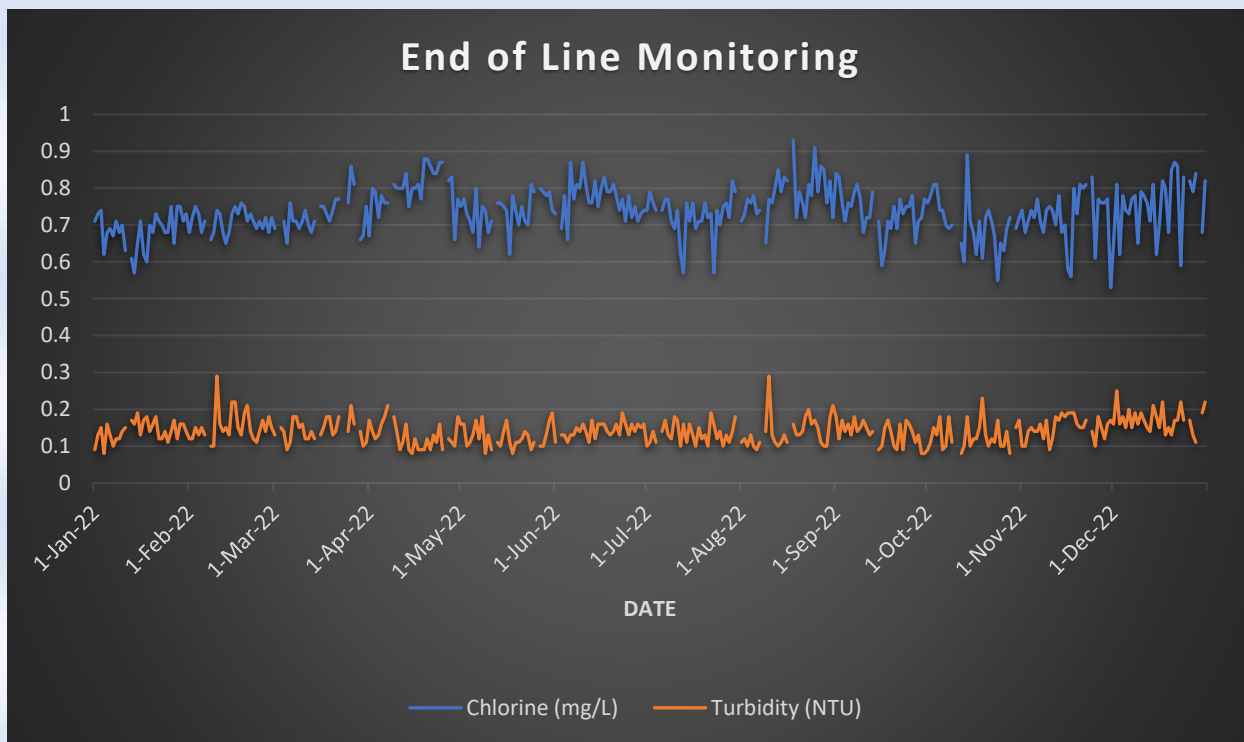
Figure 3

Turbidity is one of the most important measurements a water operator conducts. Turbidity is a measurement of the clarity of the water and gives an indication on the number of particles in the water that can't be seen by the naked eye. A rise in turbidity can help alert an operator to changes in raw water quality. Higher turbidity (more particles) can harbor microorganisms, shielding them from disinfection. For a water system that uses ground water, turbidity levels should never exceed 1.0 NTU. As noted below in Table 1, the highest turbidity level recorded in the Panorama distribution system was 0.30 NTU.
