# 2024 ANNUAL DRINKING WATER REPORT

## PANORAMA MOUNTAIN RESORT

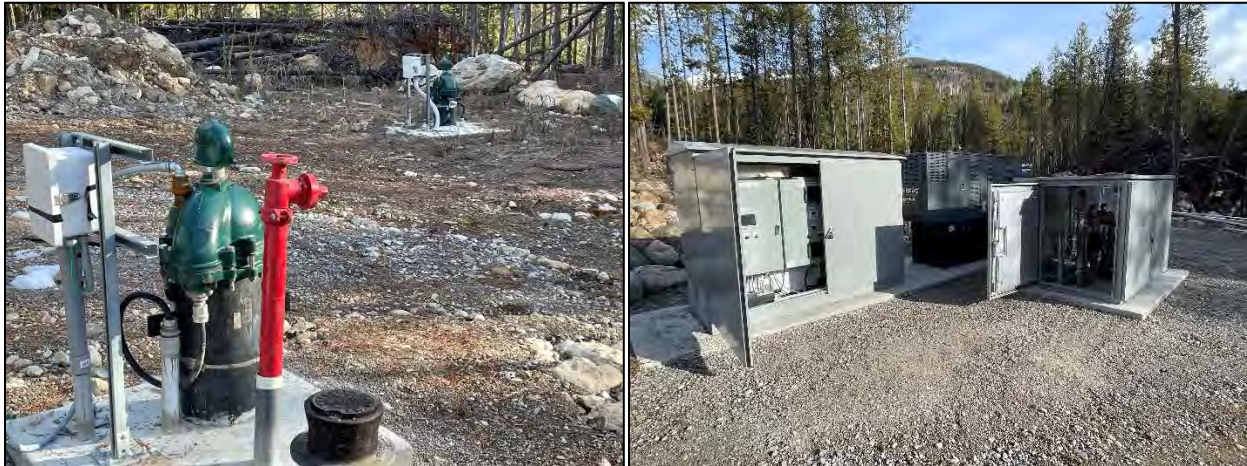
*Panorama Well Site*

Panorama's source water is from two, 10-inch diameter production wells near the Toby Creek. In 2020, Bluestem transitioned from a surface water source to a clean groundwater source to alleviate the high levels of turbidity in the water during spring runoff. Well 15-02 has a total depth of 32.5m (106.5 ft) and well 20-03 has a total depth of 37.9m (124.5 ft). Both wells have been drilled into the same semi-confined sand and gravel aquifer system. This system is overlain by sediments containing silt and clay, while it is underlain by bedrock.

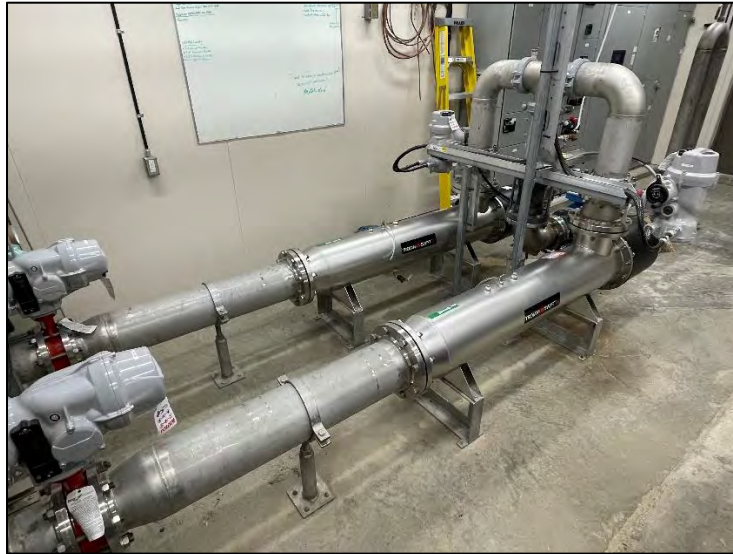
*Panorama UV disinfection units*

Panorama's source water is continuously pumped to a treatment station located at 2130 Trappers Way. There is continuous online turbidity monitoring for all water entering the treatment station. The first stage of disinfection is UV. Bluestem operates two Trojan UV Swift SC units. This UV disinfection process provides 99.99% inactivation of pathogens such as *Cryptosporidium* and *Giardia*. The next stage of disinfection is accomplished with chlorine. Bluestem administers a dosage using 12% Sodium Hypochlorite. The level of chlorine leaving the treatment station is continuously monitored, and is usually around 0.90 mg/L. The combination of using UV technology and chlorine disinfection creates a very efficient disinfection process by inactivating many microorganisms.

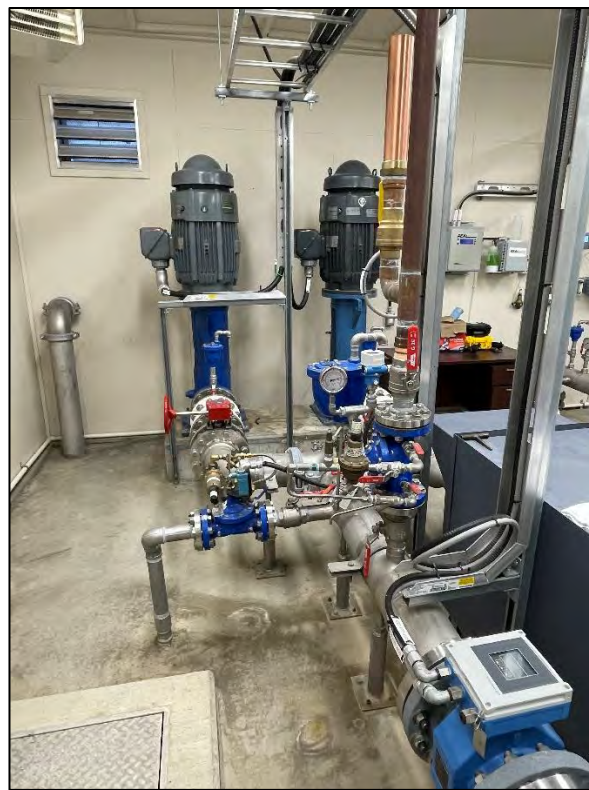
*Treatment Station Booster Pumps*

After disinfection is accomplished, the water is pumped into a clear well, which is located underneath the treatment station. This acts as a holding tank, as two booster pumps then move the water from the treatment station to the main resort reservoir. As water demands increase and decrease all tank levels remain constant as well pumps and booster pumps act in unison and modulate their flow rate accordingly.

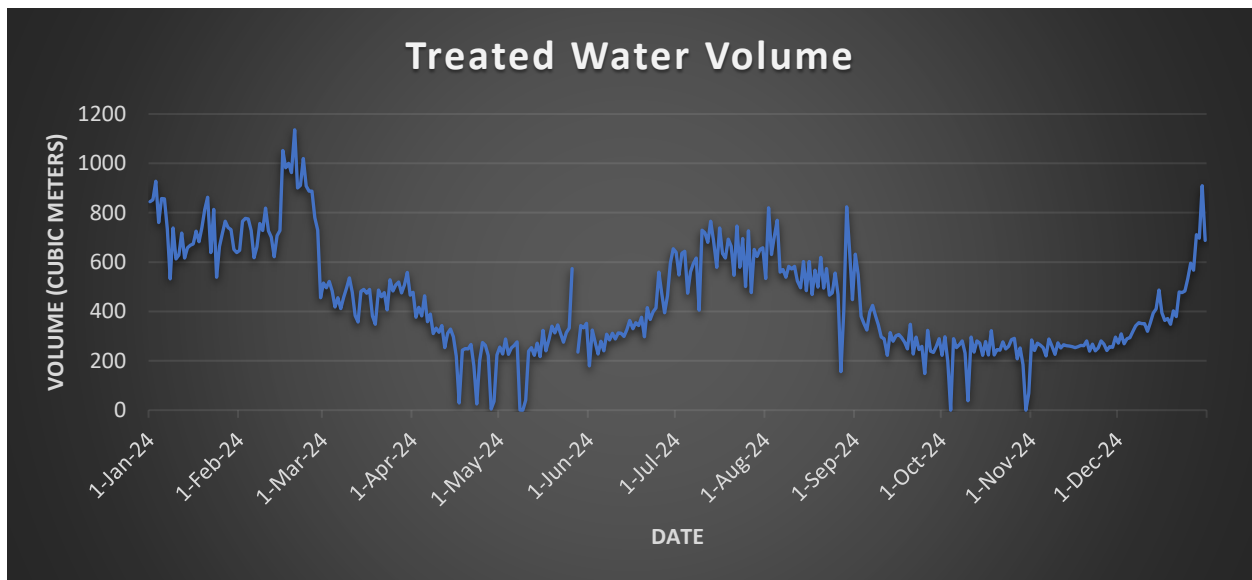
In 2024, Bluestem treated and distributed approximately 161,567 cubic meters of water (161,567,000L). Figure 1 below illustrates the amount of water that was treated daily over the course of the year. As can be seen, there are fluctuations throughout the year. This is because Panorama is a seasonal resort destination. Higher flows can be expected through winter months (Dec – Apr) and summer months (Jul – Sept) due to higher occupancy rates. Summer irrigation also factors into a higher demand during summer months.

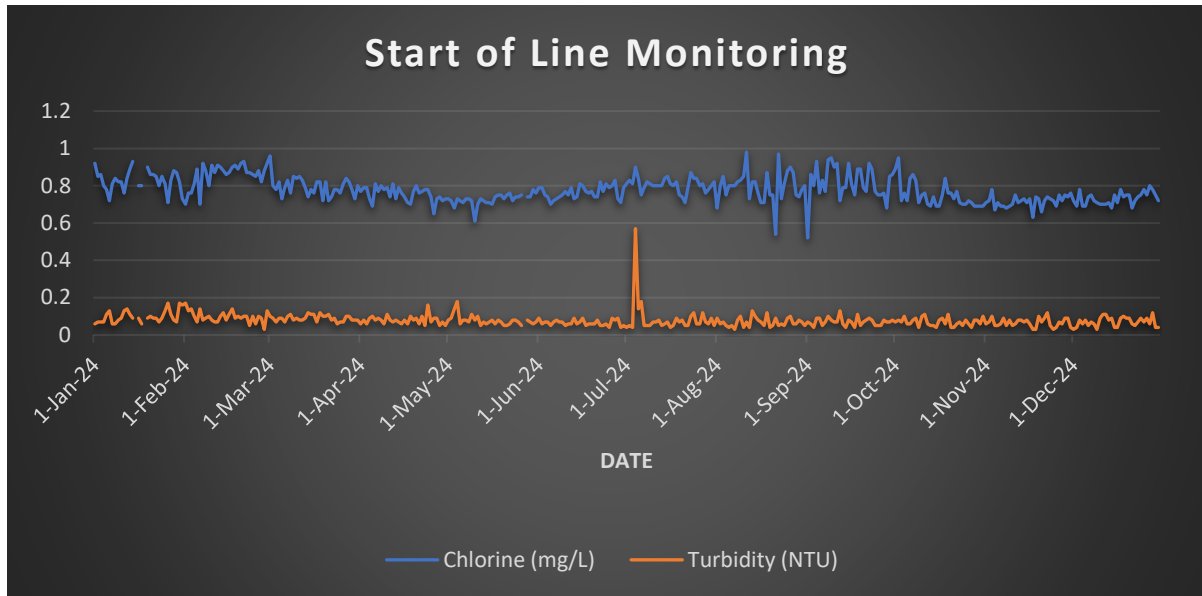
Every day, Bluestem operators perform a set of daily rounds consisting of operational checks of the well site and booster station. Turbidity and residual chlorine checks are also completed everyday by an operator. Please refer to Figure 2 and Figure 3 for a snapshot of chlorine and turbidity levels found at the start and near the end of the distribution system throughout 2024. By completing these checks at both the start and end of line, this ensures an adequate chlorine residual and turbidity level throughout the entire system.

As seen in Figure 2 & 3 on the following page, chlorine and turbidity levels remained consistent throughout the year. The turbidity spike found on July 4, 2024, can be attributed to operator error in data entry as this was not detected by any continuous monitoring device, nor was it seen in other parts of the distribution system.

Chlorine residual concentrations usually range from 0.20 to 2.0 mg/L in many Canadian drinking water distribution systems. Bluestem operators try to keep the residual around 0.80 mg/L through the system to ensure proper disinfection while minimizing the taste of chlorine for the customer. As noted in Table 1, the average chlorine residual at the start and the end of the distribution system were 0.78 mg/L and 0.74 mg/L respectively.
