2025 ANNUAL DRINKING WATER REPORT

PANORAMA MOUNTAIN RESORT

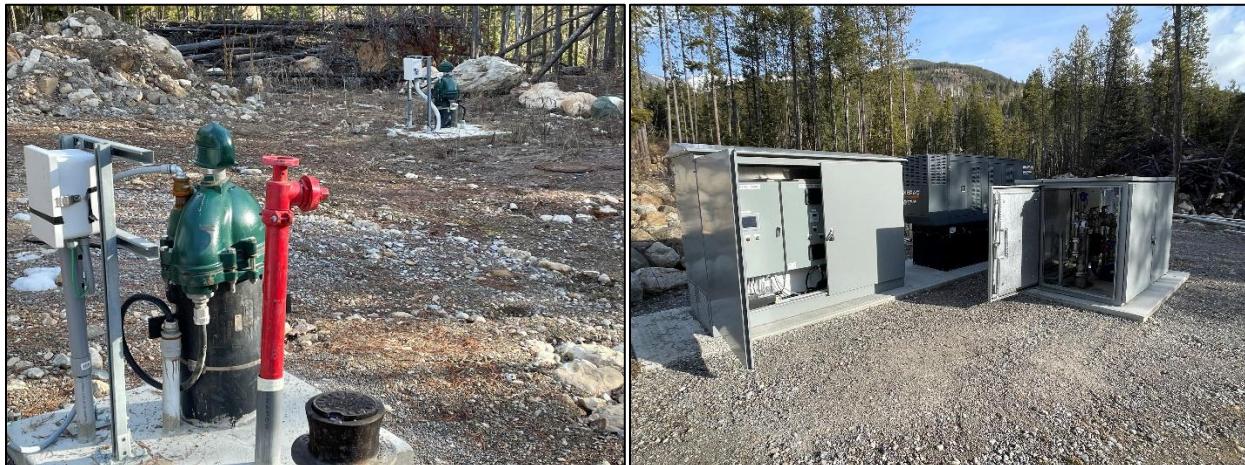
Panorama Well Site

Panorama's source water is from two, 10-inch diameter production wells near the Toby Creek. In 2020, Bluestem transitioned from a surface water source to a clean groundwater source to alleviate the high levels of turbidity in the water during spring runoff. Well 15-02 has a total depth of 106.5 ft (32.5m) and well 20-03 has a total depth of 124.5 ft (37.9m). Both wells have been drilled into the same semi-confined sand and gravel aquifer system. This system is overlain by sediments containing silt and clay, while it is underlain by bedrock.

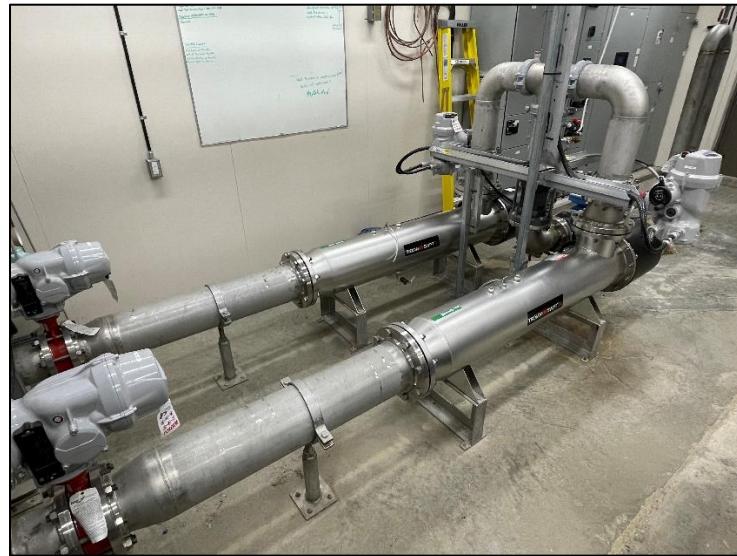
Panorama UV disinfection units

Panorama's source water is continuously pumped to a treatment station located at 2130 Trappers Way. There is continuous online turbidity monitoring for all water entering the treatment station. The first stage of disinfection is UV. Bluestem operates two Trojan UV Swift SC units. This UV disinfection process provides 99.99% inactivation of pathogens such as Cryptosporidium and Giardia. The next stage of disinfection is accomplished with chlorine. Bluestem administers a dosage using 12% Sodium Hypochlorite. The level of chlorine leaving the treatment station is continuously monitored, and is usually around 0.75 mg/L. The combination of UV technology and chlorine disinfection creates a very efficient disinfection process by inactivating many microorganisms.

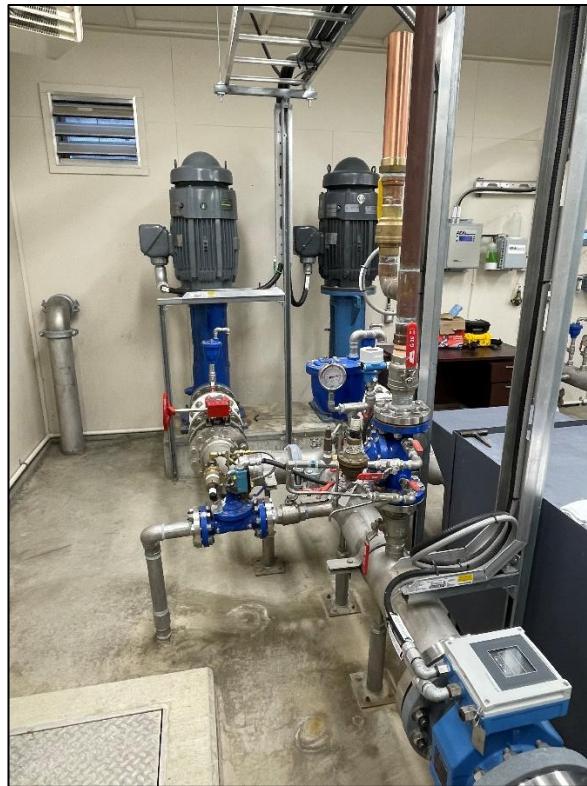
Treatment Station Booster Pumps

After disinfection is accomplished, the water is pumped into a clear well, which is located underneath the treatment station. This acts as a holding tank, as two booster pumps then move the water from the treatment station to the main resort reservoir. As water demands increase and decrease all tank levels remain constant as well pumps and booster pumps act in unison and modulate their flow rate accordingly.

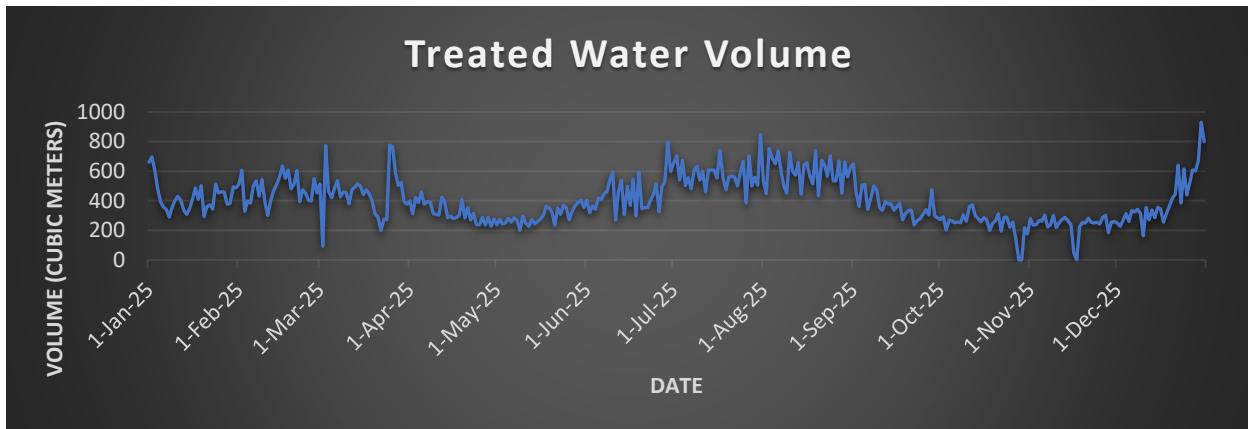
In 2025, Bluestem treated and distributed approximately 148,166 cubic meters of water (148,166,000L). Figure 1 below illustrates the amount of water that was treated daily over the course of the year. As can be seen, there are fluctuations throughout the year. This is because Panorama is a seasonal resort destination. Higher flows can be expected through winter months (Dec – Apr) and summer months (Jul – Sept) due to higher occupancy rates. Summer irrigation also factors into a higher demand during summer months.

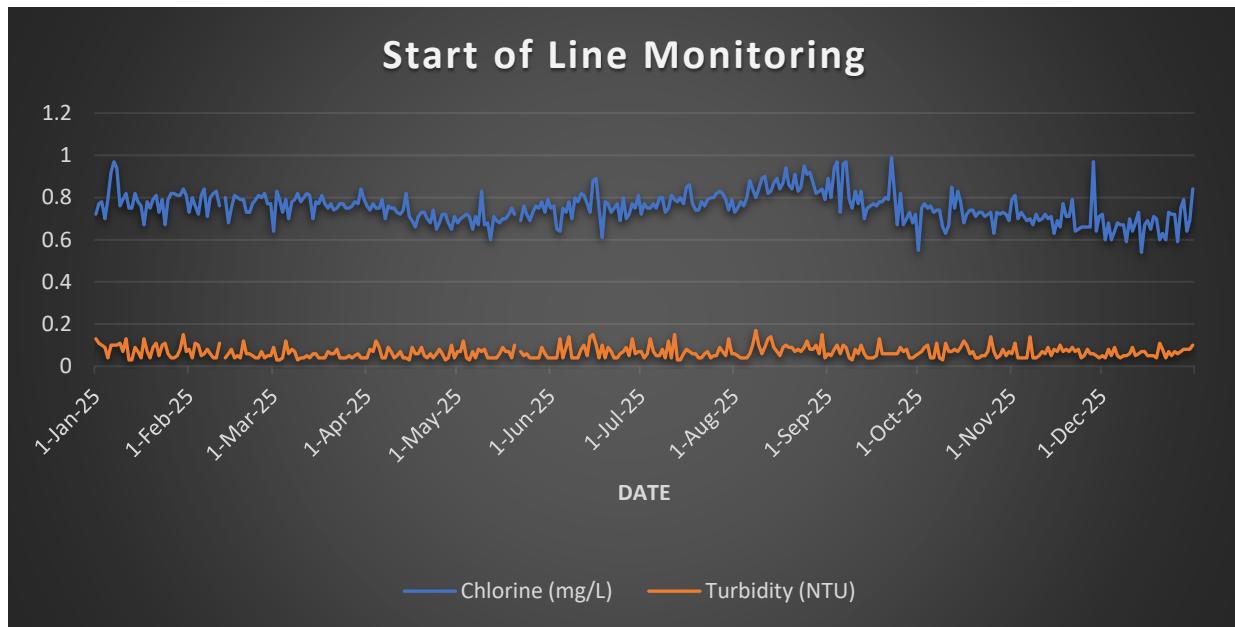
Every day, Bluestem operators perform a set of daily rounds consisting of operational checks of the well site and booster station. Turbidity and residual chlorine checks are also completed everyday by an operator. Please refer to Figure 2 and Figure 3 for a snapshot of chlorine and turbidity levels found at the start and near the end of the distribution system throughout 2025. By completing these checks at both the start and end of line, this ensures an adequate chlorine residual and turbidity level throughout the entire system.

Chlorine residual concentrations usually range from 0.20 to 2.0 mg/L in many Canadian drinking water distribution systems. Bluestem operators try to keep the residual around 0.75 mg/L through the system to ensure proper disinfection while minimizing the taste of chlorine for the customer. As noted in Table 1, the average chlorine residuals at the start and the end of the distribution system were 0.72 mg/L and 0.75 mg/L respectively.

As seen in Figure 2 & 3 on the following page, chlorine and turbidity levels remained consistent throughout the year.

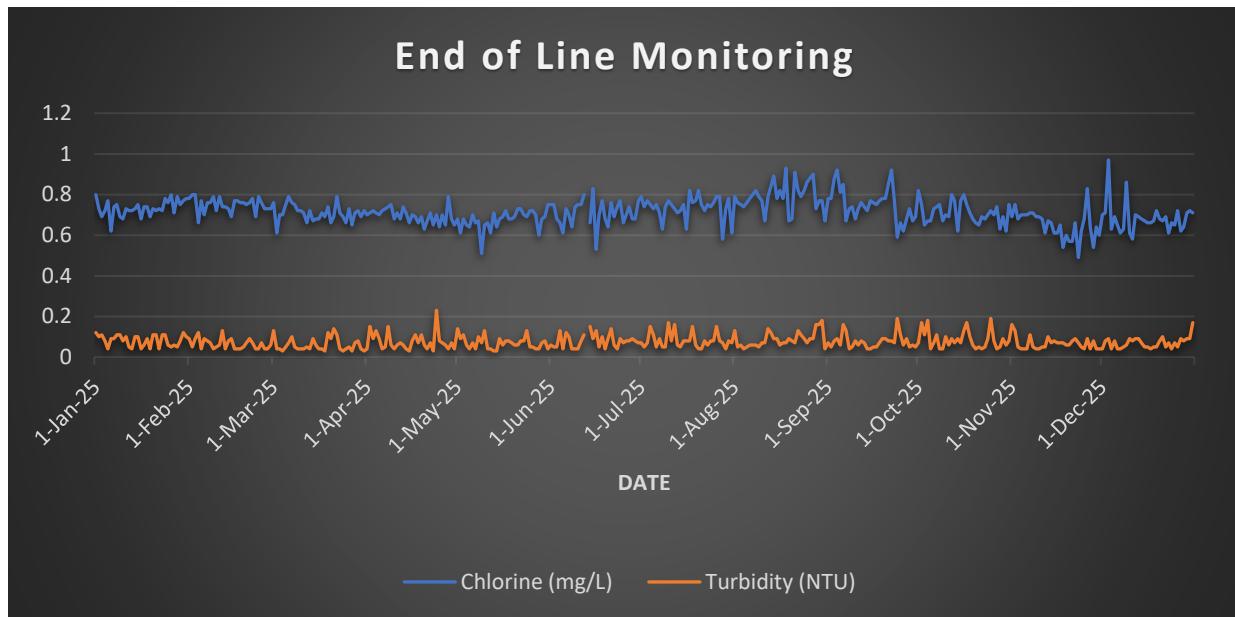
Figure 3

Turbidity is one of the most important measurements a water operator conducts. Turbidity is a measurement of the clarity of the water and gives an indication of the number of particles in the water that can't be seen by the naked eye. A rise in turbidity can help alert an operator to changes in raw water quality. Higher turbidity (more particles) can harbor microorganisms, shielding them from disinfection. For a water system that uses ground water, turbidity levels should never exceed 1.0 NTU. As noted in Table 1, the average turbidity level at the start and the end of the distribution system was 0.07 NTU.

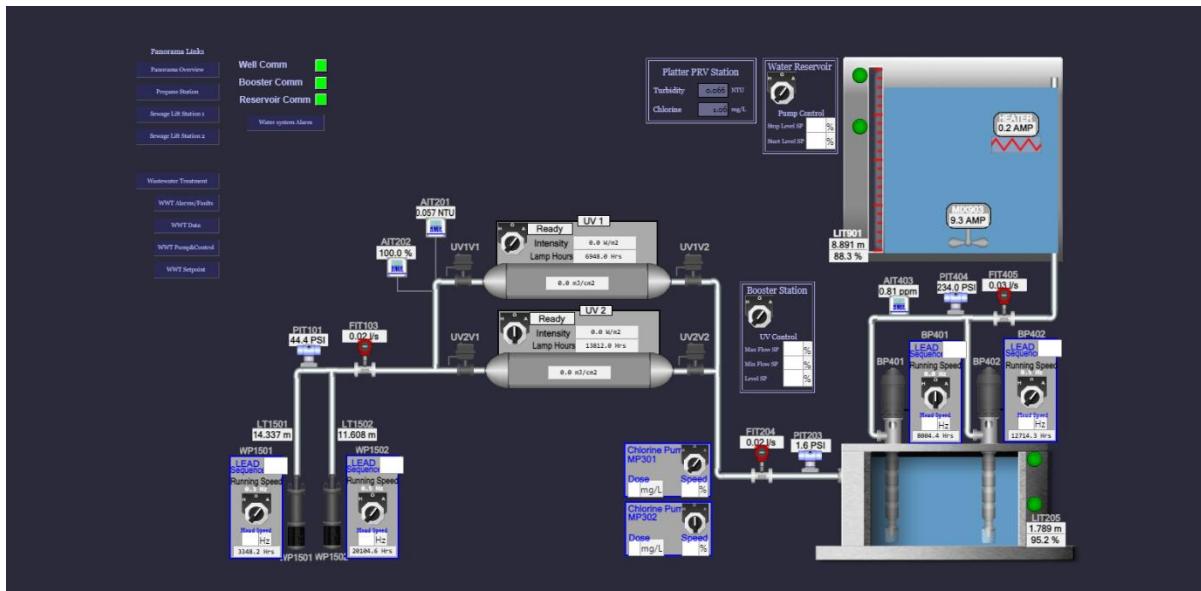
Figure 4

Bluestem utilizes a SCADA (Supervisory control and data acquisition) system to monitor all critical components and operations of the water treatment system. The SCADA system allows Bluestem operators to monitor alarms, adjust treatment processes and accumulate data. This allows the operator to respond to events or look at data trends, regardless of location. Below (Figure 3) is screen shot of the Panorama water treatment process on SCADA. Pump controls, reservoir levels and crucial parameters such as chlorine and turbidity are all displayed.
